EARTHQUAKE RETROFIT PROPOSAL FOR OUR MEETING HOUSE

June 8, 2020

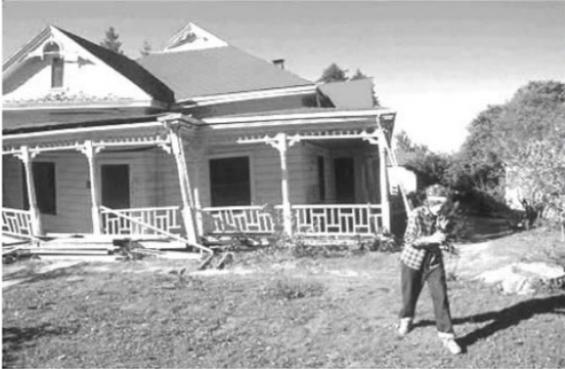
Figure 2 - Loma Prieta Earthquake, Oct. 17, 1989
Home moved off of its foundation and was considered a total loss.

Caption: This photo along with the caption are from a State of California document. The caption notes that the house was “considered a total loss.” The house appears to be wood-frame, like our Meeting House. It, like our Meeting House, was not bolted to its foundation. The house experienced the Loma Prieta quake, magnitude 6.9, in the Santa Cruz Mountains south of San Francisco. That approaches the maximum magnitude, 7.0 that a quake in the vicinity of the Meeting House might generate. During the Loma Prieta quake, the house slid out of position on its foundation.

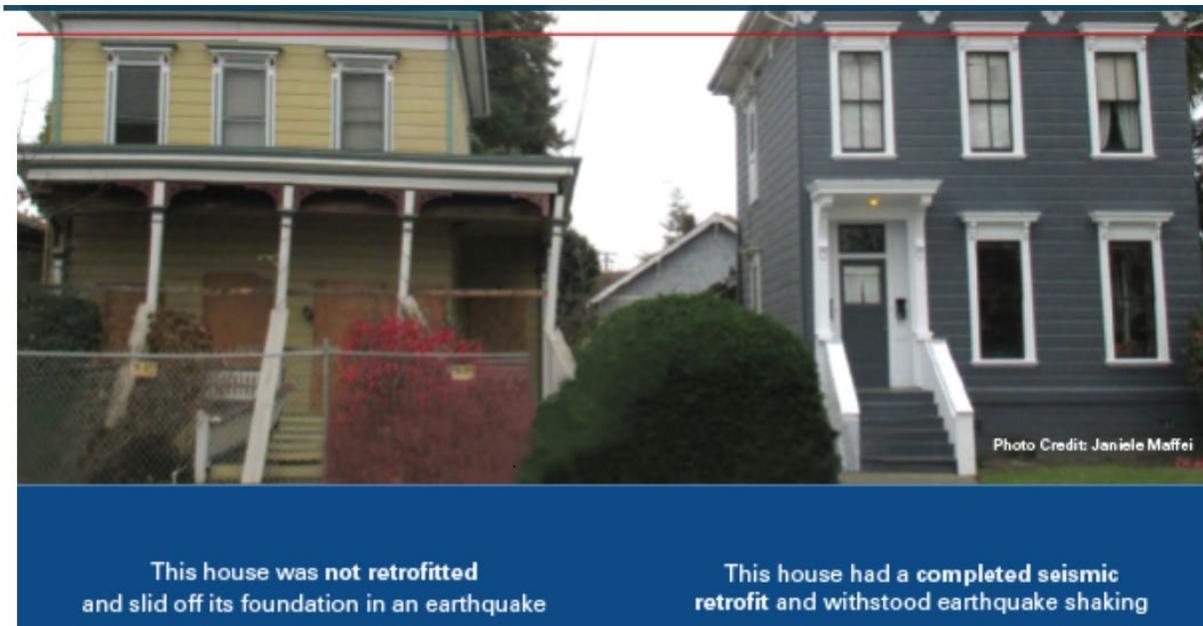
These two houses, next door to each other, experienced the South Napa Earthquake, magnitude 6.0. (Anticipated maximum 7.0 quakes within 3 miles of our Meeting House would release 32 times more destructive energy than the South Napa quake.) Both houses are wood-frame like our Meeting House. The house on the right was retrofitted and did not experience major structural damage. The house on the left was not retrofitted, slid away from its foundation, and experienced major structural damage. This is indicated by the tilted rooflines and pillars on the porch. A red line drawn across the top of the photo shows how the roofline of the house on the left has tilted, whereas it has remained horizontal on the right. Note the chain link fence in front of the house on the left to prevent entry. [Source: [California Earthquake Authority](#), a nonprofit organization that offers earthquake insurance, established by the California Legislature]
